**Phase II Environmental Assessment Report
GoCold Ltd
Old Station Yard
Meldreth
Royston
Cambridgeshire
SG8 6JR**

**Trustees of the GoCold Pension Fund
C/O GoCold Ltd
Station Yard
High Street
Meldreth
Royston
SG8 6JR**

EPS Project: UK09.0787
Report Status: Final
Date Issued: 13th January 2011

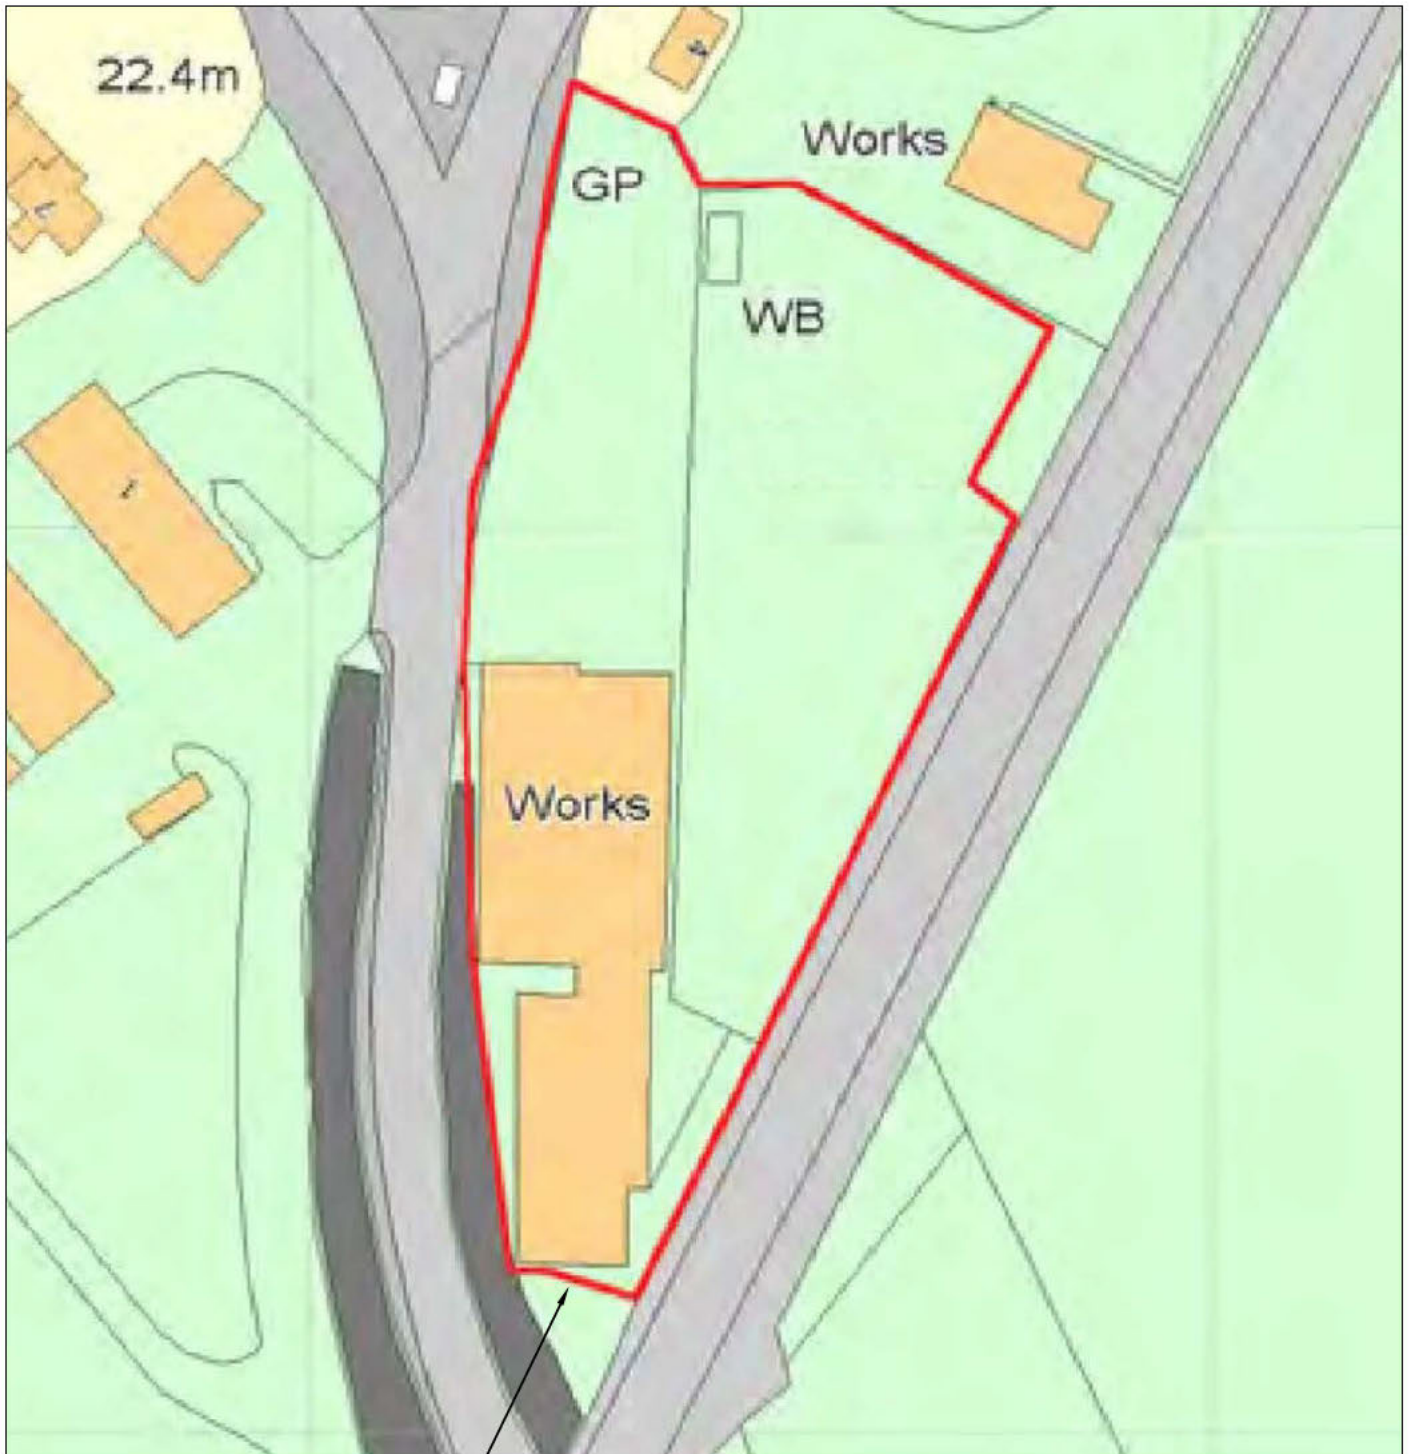
Title:	Site Layout Plan	
Project:	Go Cold Ltd, Old Station Yard, Meldreth, Royston, SG8 6JR	Scale: Not to scale
Client:	GoCold Pension Fund C/O GoCold Ltd	Drawn By: TJ Approved By: GL
Fig No:	2	Job No: UK09.0787
		Dwg No: GoCold/Meldreth/0111/2
		Date: 10th January 2011

Site Location and Description	<p>The site is located in the southern area of the village of Meldreth, Cambridgeshire (see Figure 1). The site is irregular in shape, measuring a total surface area of approximately 5,200m² and lies at an approximate topographic elevation of 22m above ordnance datum; the site itself is relatively level.</p> <p>The site is currently used by a company that manufactures and supplies ice cream; 'GoCold Ltd.' A factory building lies in the south-western quarter of the site, which houses a cold-store, a vehicle loading area and administrative offices. The remaining site area is principally covered by concrete hardstanding with small tarmac areas and is currently used as car-parking, for access and overnight parking of delivery vehicles. Soft landscaped areas border the site to the west and southwest.</p> <p>Development proposals include partial demolition of the northern half of the existing facility and subsequent redevelopment to include an extended cold storage warehouse, loading bays and associated new offices. The yard area will also be refurbished to formalise staff parking and delivery vehicle access routes and small landscaped areas will be introduced. Plans showing the site layout and proposed development layout are included as Figure 2 and Appendix B respectively.</p>

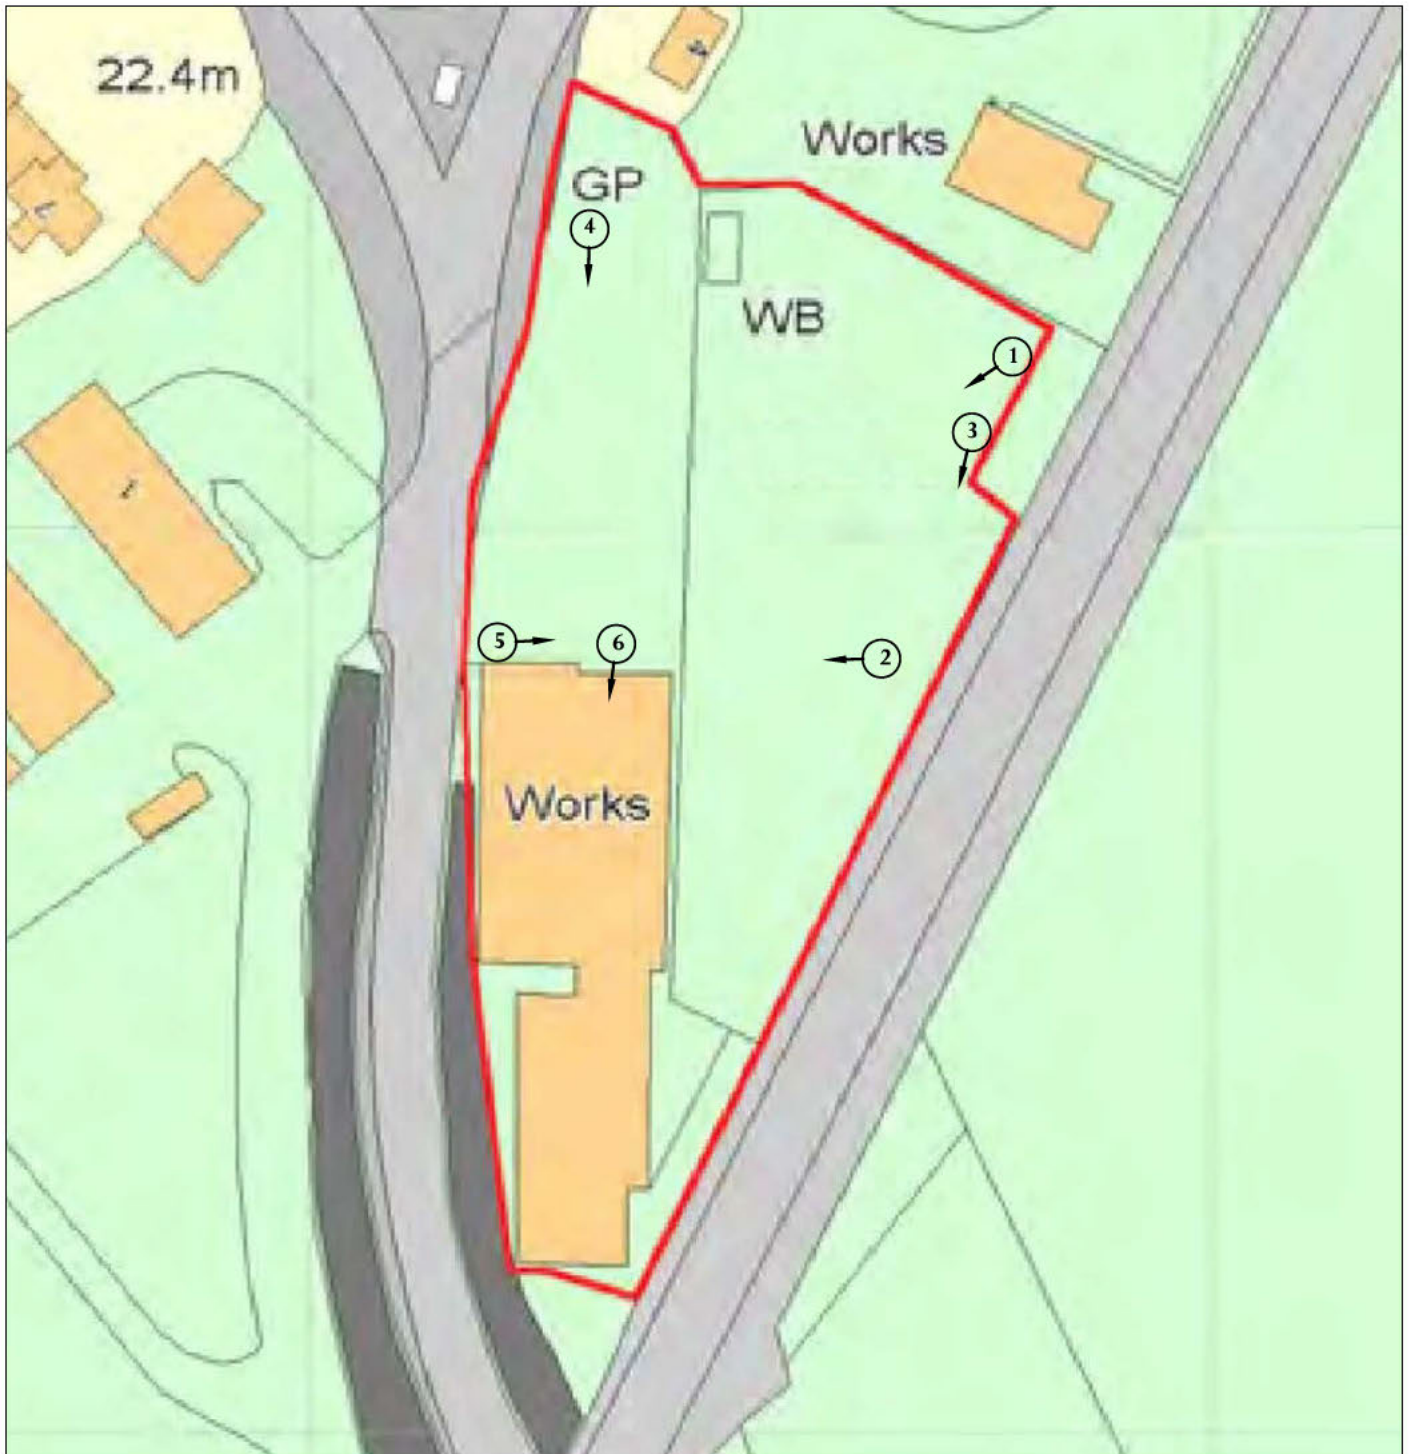
Selected Site Photographs & Photograph Location Plan

Scale:	Not to scale	
Drawn By:	TJ	Approved By: GL
Job No:	UK09.0787	
Dwg No:	GoCold/Meldreth/0111/B	
Date:	10th January 2011

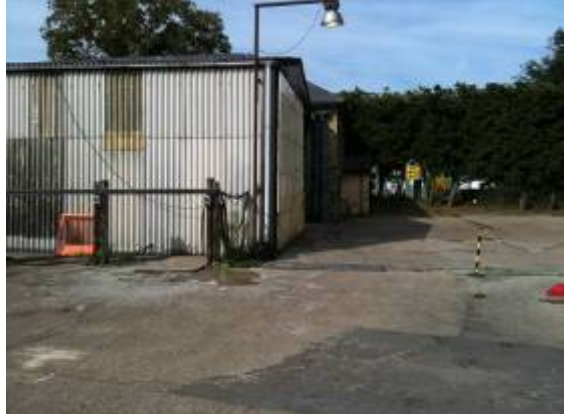
<p>Photo 1: View looking southwest from the north-eastern corner of the site</p>	<p>Photo 2: View looking west across the existing on-site building and the locations of WS1, TP1 and TP2.</p>

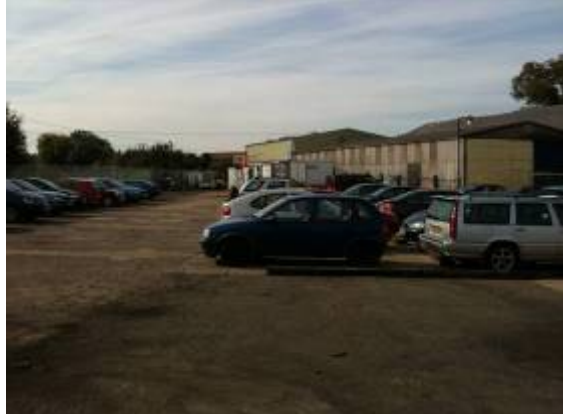
<p>Photo 3: View looking south from the north-eastern corner of the site</p>	<p>Photo 4: View looking south from the north-western corner of the site.</p>

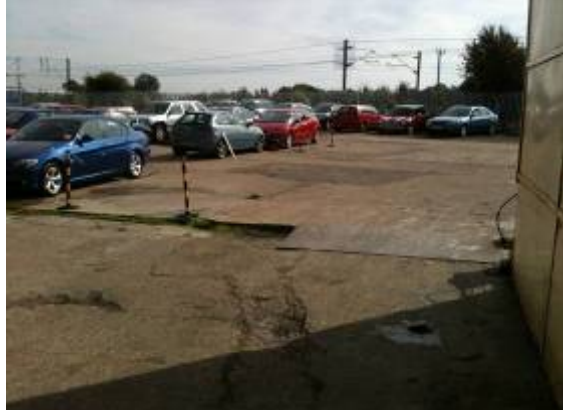
<p>Photo 5: View looking east across the location of borehole WS1</p>	<p>Photo 6: View of trial pit TP1.</p>

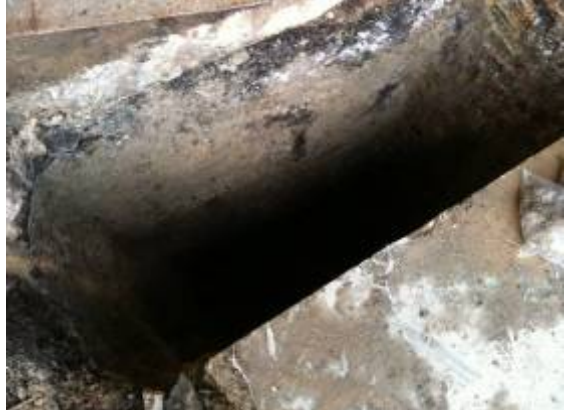
A limited quantity of ash, brick and clinker material was noted in the made ground, which was encountered across the site however no other physical evidence of contamination, such as staining or odour in soil or groundwater was encountered in any of the excavations made during the investigation.
