CAMBRIDGE EAST

Contaminated Land
RAG Assessment
December 2020

Contaminated Land RAG Assessment

Document reference: 400182 | CE01 | 01 |

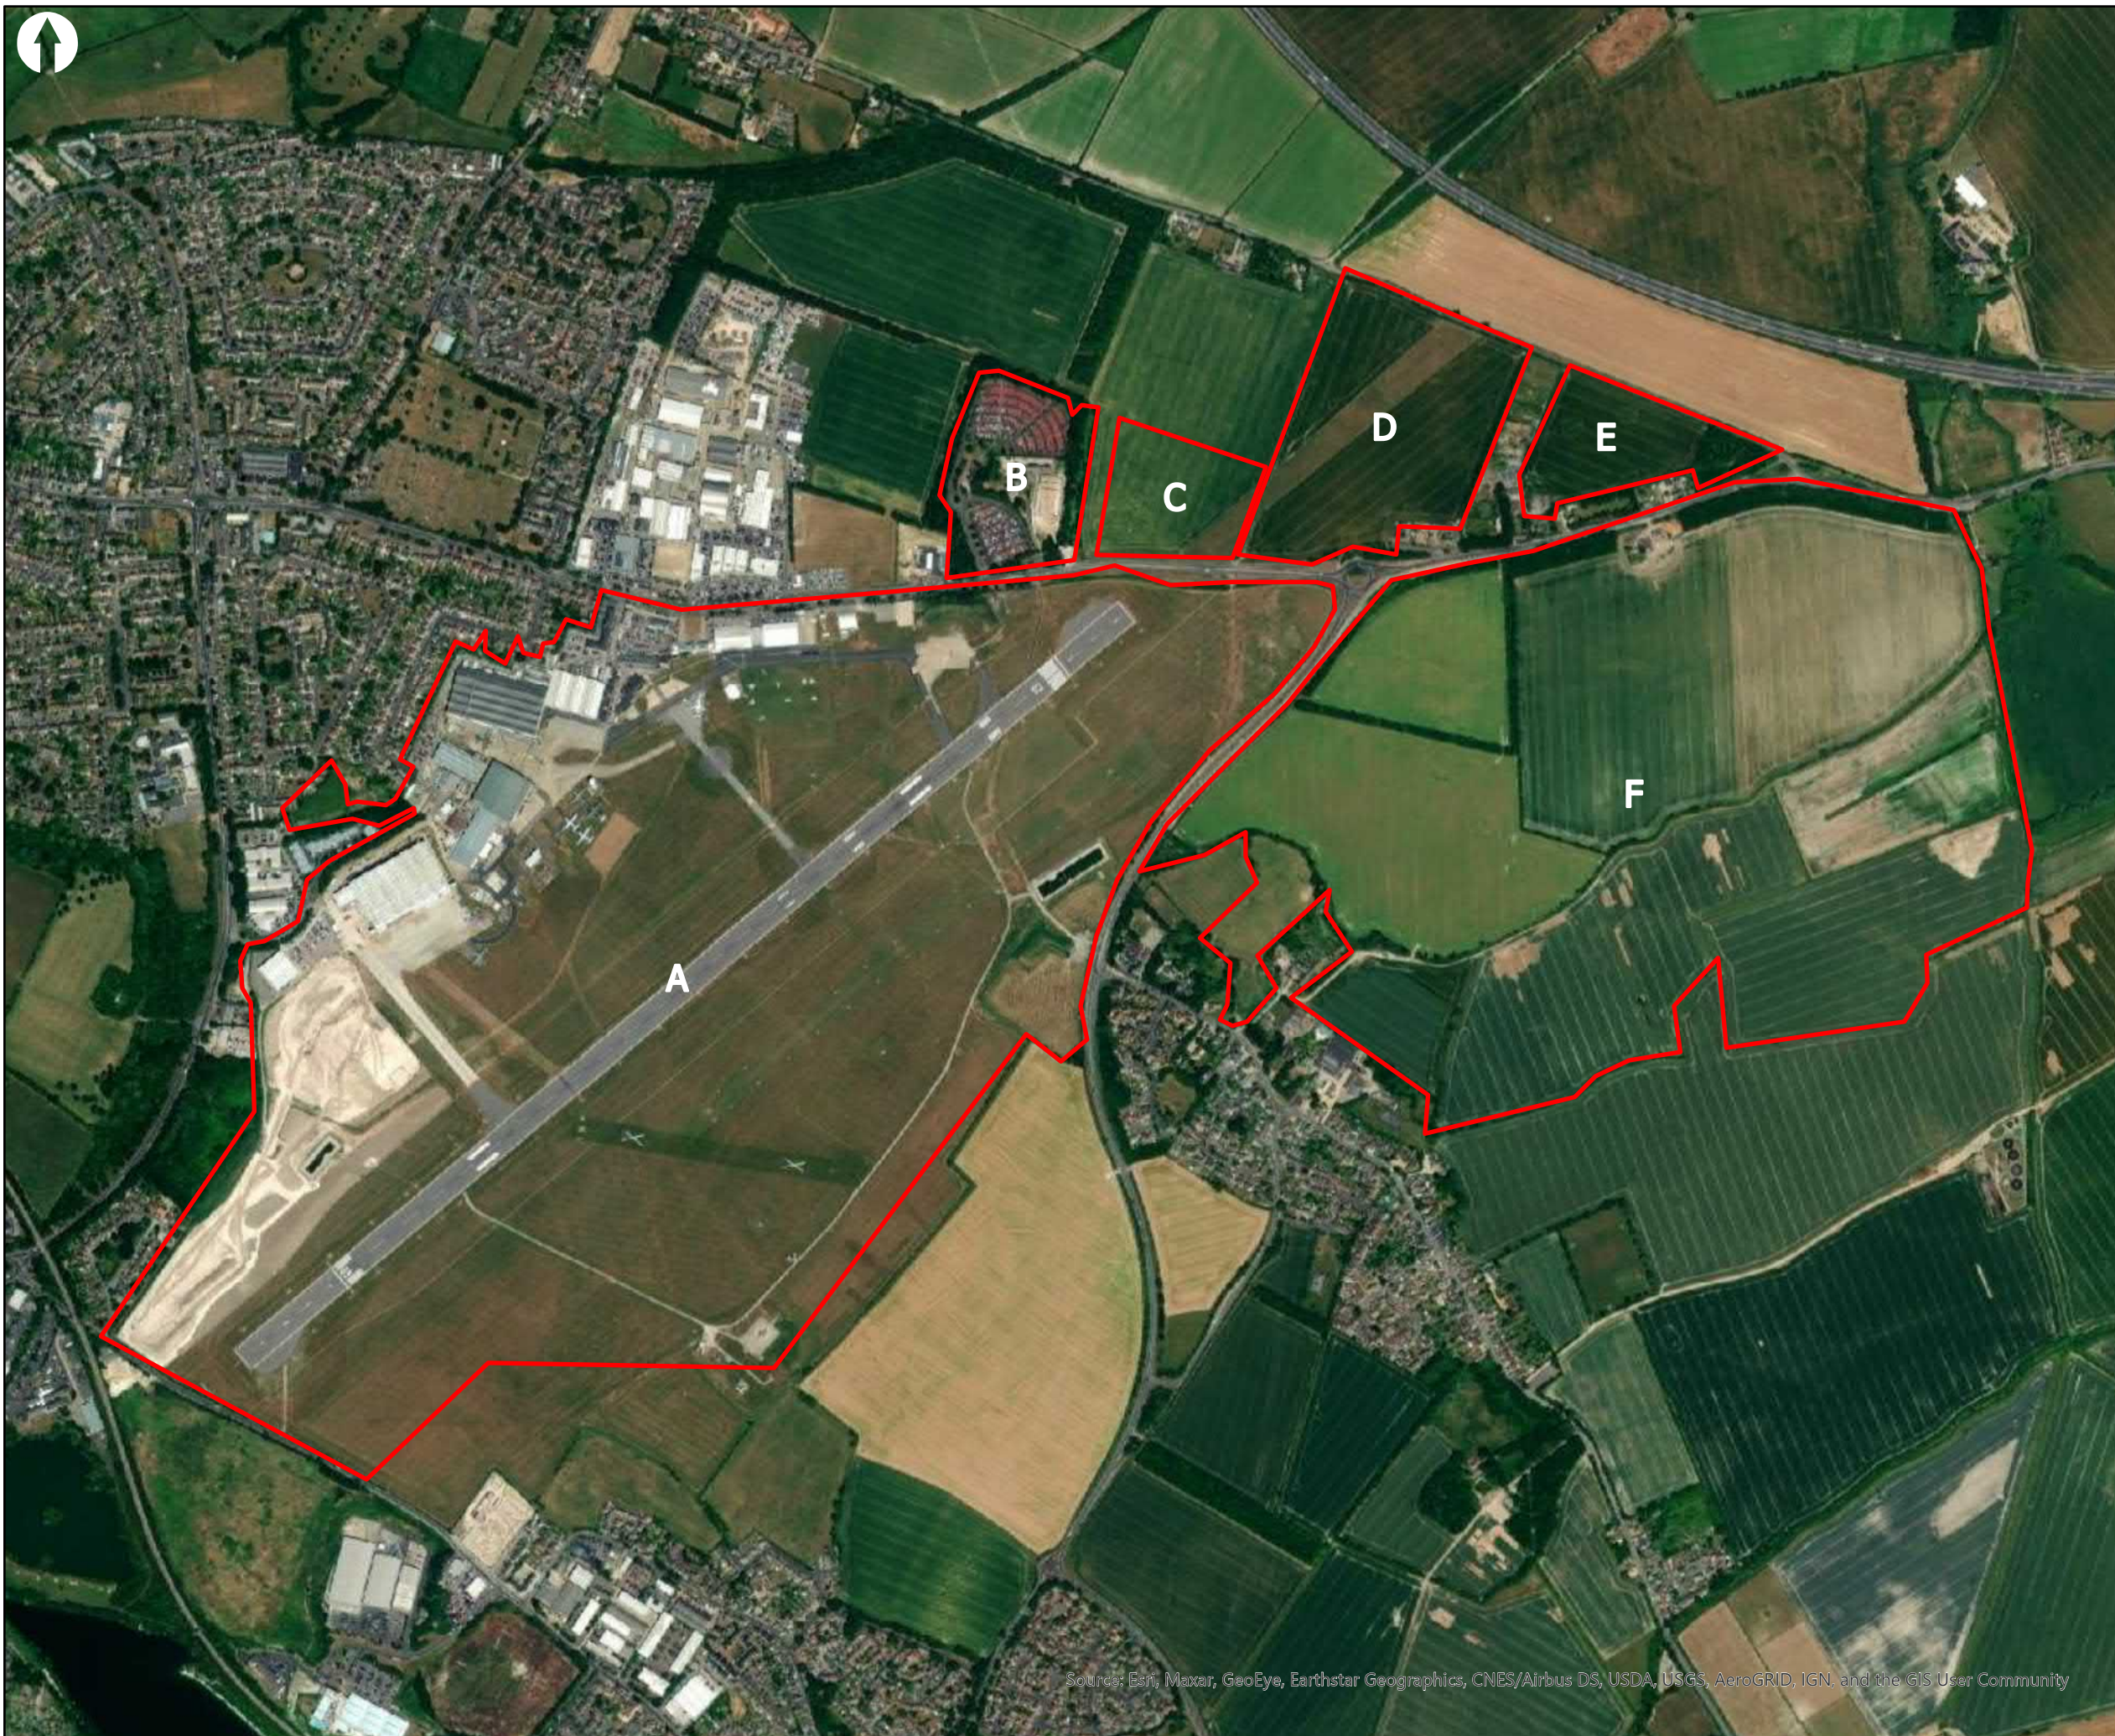
The site comprises Cambridge Airport (Plot A) and an area of mostly greenbelt that lies to its east (Plots B-F). A site location plan can be seen in Figure A.1 (Appendix A).

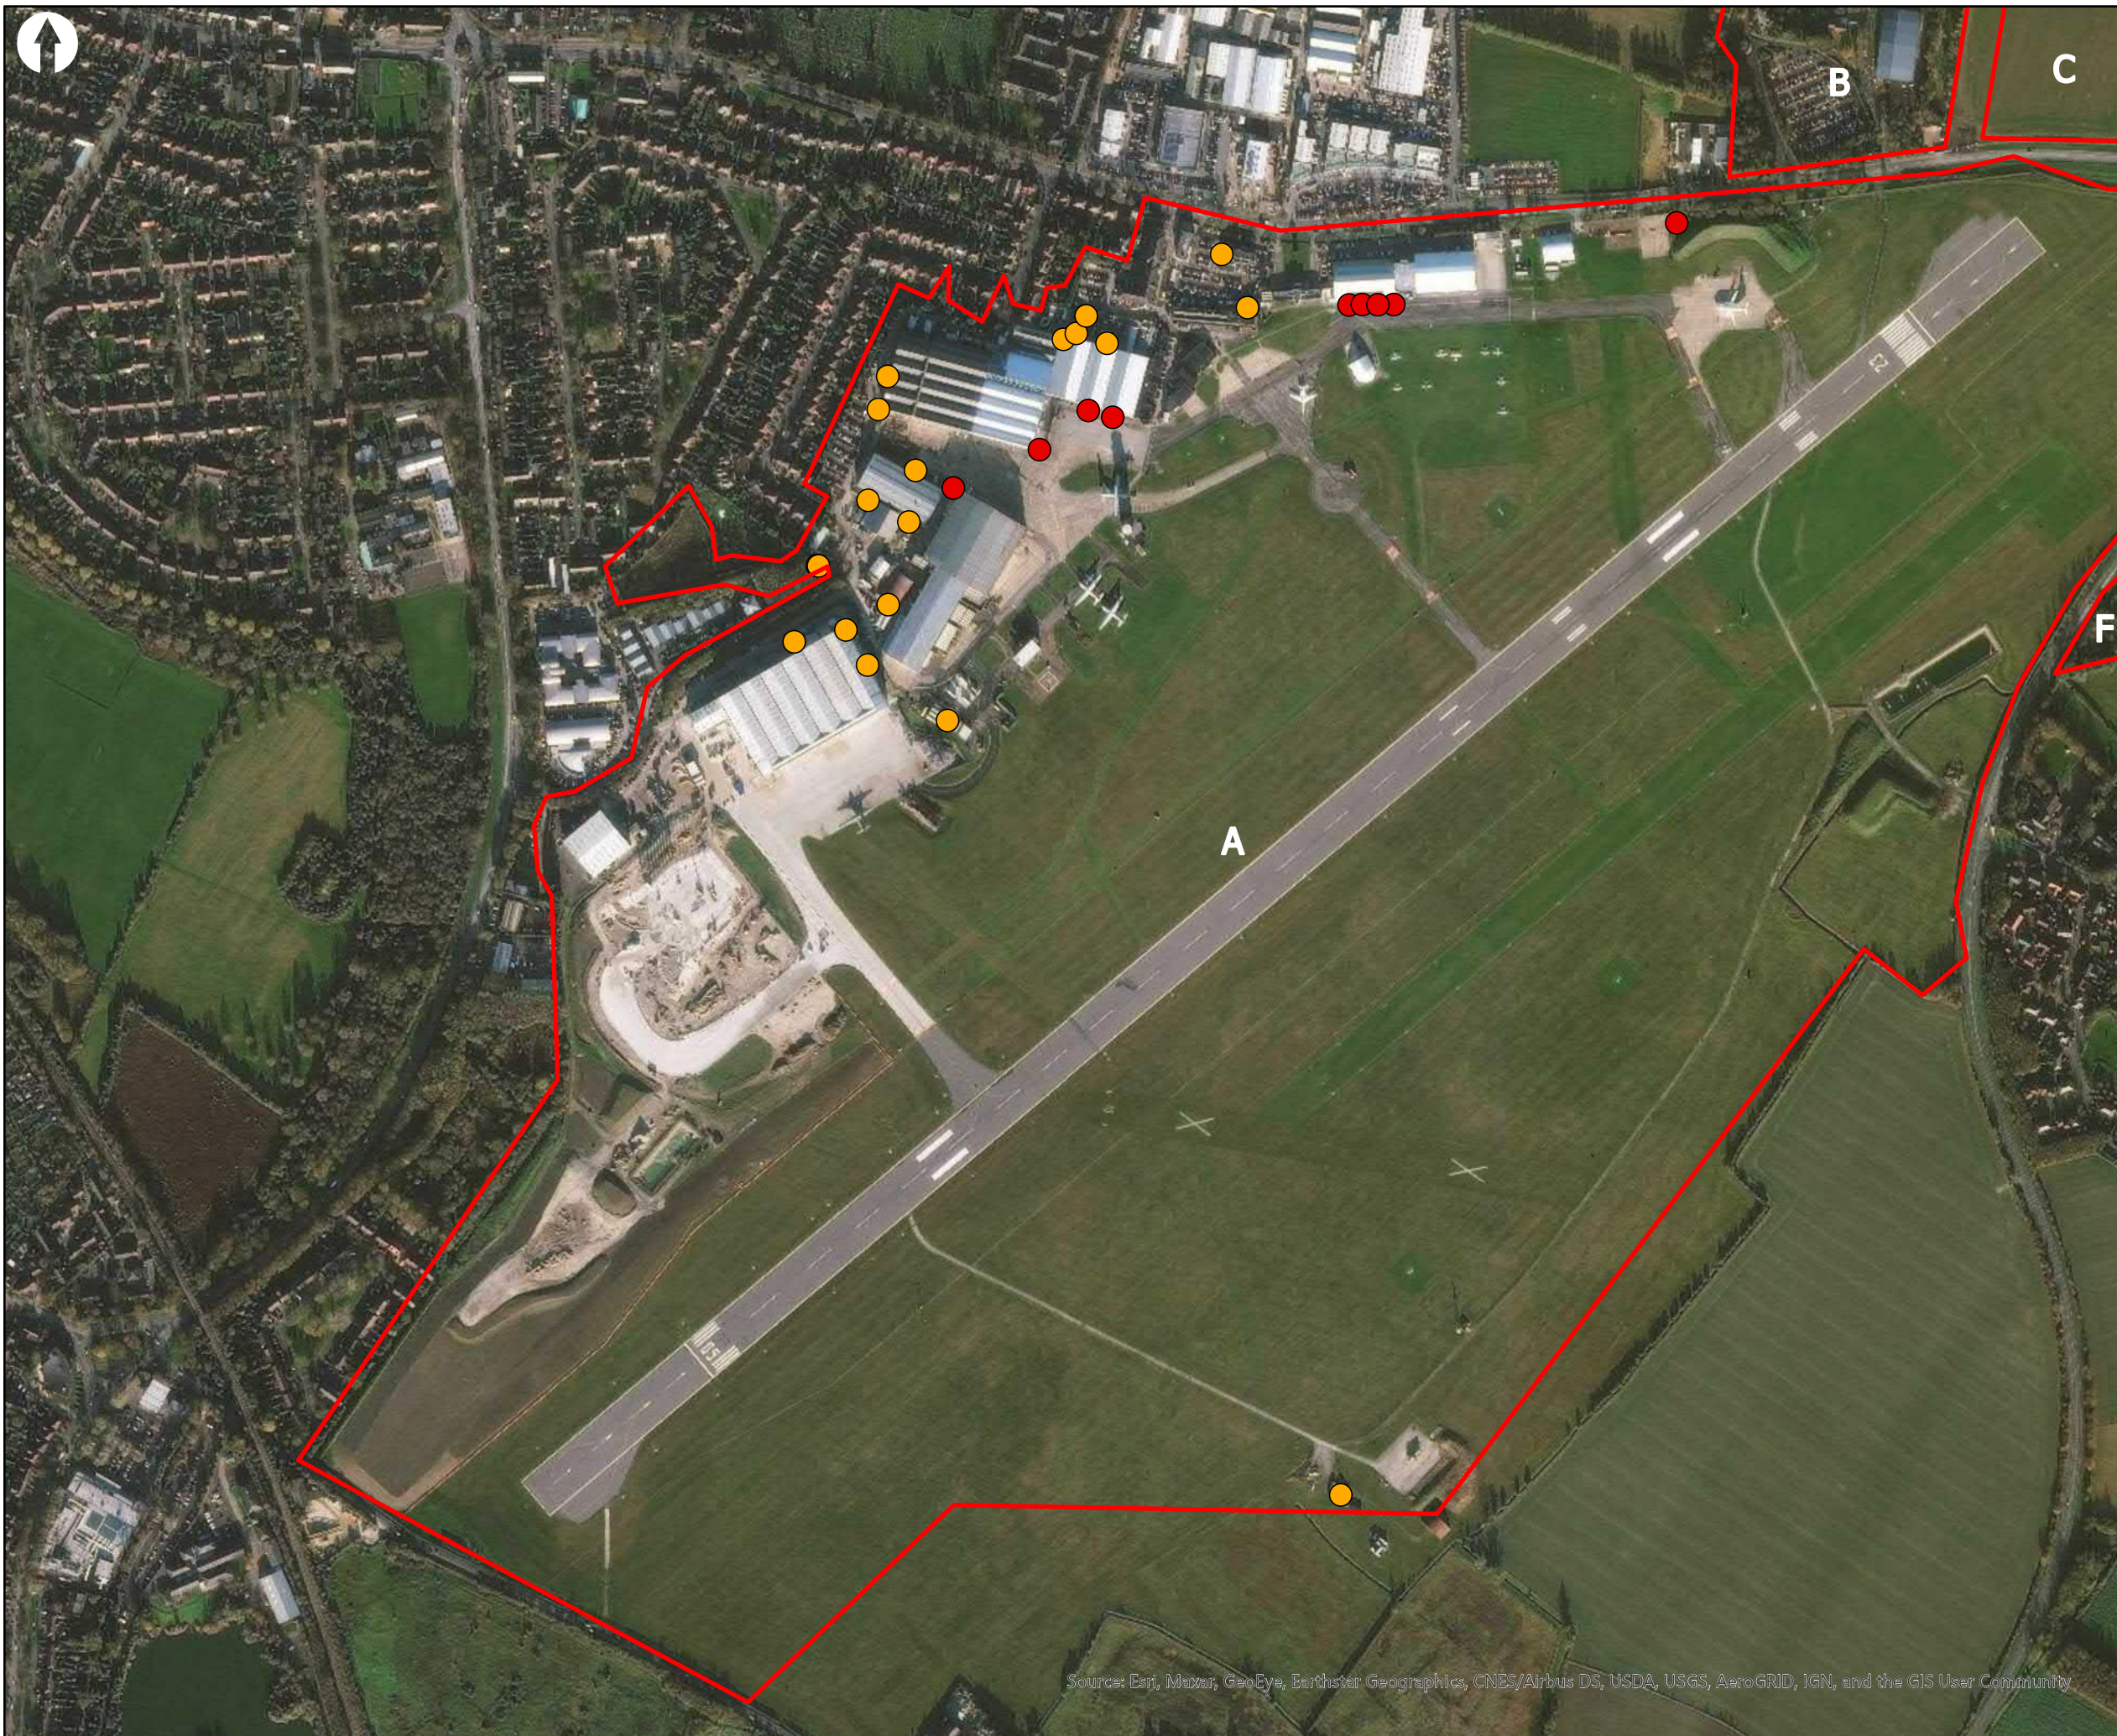
A.5 Liquid Storage Facilities (USTs and ASTs)

The location of these tanks can be seen in Figure A.5 (Appendix A).

The location of these can be seen in Figure A.5 (Appendix A).

- Red Line Boundary
- Liquid Storage Facilities (above ground)
- Underground Storage Tanks (disused)

There are nine Underground Storage Tanks (USTs) located within the South Works and Airport site. These contained either jet fuel or aviation gasoline. The tanks were installed between 1937 and 1982. Two tanks adjacent to Hangar 1 were removed in 2008 and a tank adjacent to the Engine Running Mound was removed in 2003. The remaining tanks have been decommissioned.

There are several above-ground storage tanks (AST) located on the South Works. These are predominantly used to store fuel oil, waste oil and developer fluid (Non-Destructive Testing (NDT) building). These, alongside an environmental compound and liquid oxygen compound, are located on the South Works. In addition, foams associated with the fire training ground are stored south of Plot A, adjacent to the FTG.

Marshall has a licence for dispensing and storage of fuel under a Petroleum Licence from Trading Standards. The AST are reported, by Marshall, to be compliant with the Control of Pollution (oil storage) Regulations, 2001. Some tanks are no longer in use but remain in-situ (cleaned and decommissioned), whilst those that remain either have continuous pour concrete bunding or an integral arrangement.
