Tree protection BS 5837: 2012
-

For No 2 HARDWICK RD  
 TOTT

Drawing number LD 14 3291

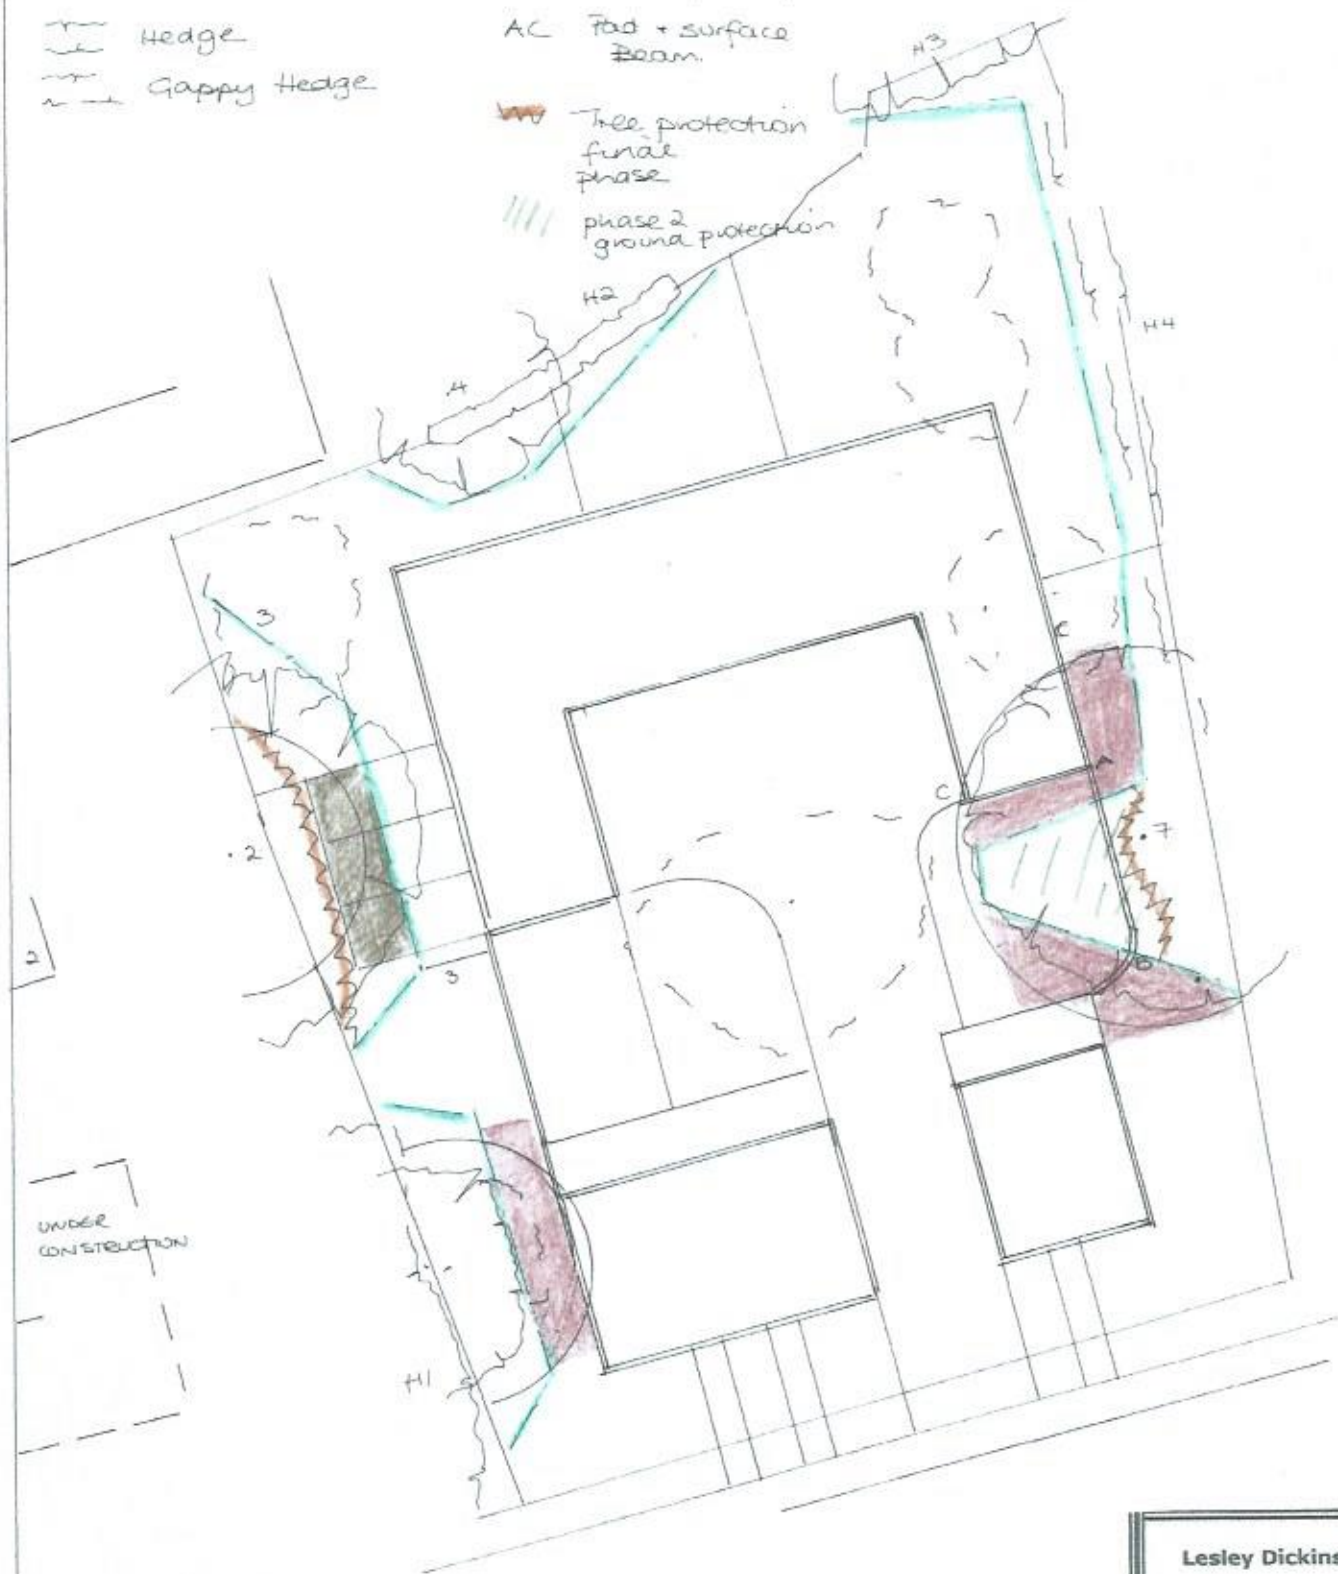
-   Canopy
-   RPA
-   Remove/cut back
-   Hedge
-   Gappy Hedge

Ground protection
-   AB Pad + lintel wall
-

No dig car park
-

AC Pad + surface beam
-

Tree protection final phase
-

phase 2 ground protection
